# Bulk Fuel Itinerant AST Training Checklist

**Pedro Bay Community Fuel Facility**

Inspection Date

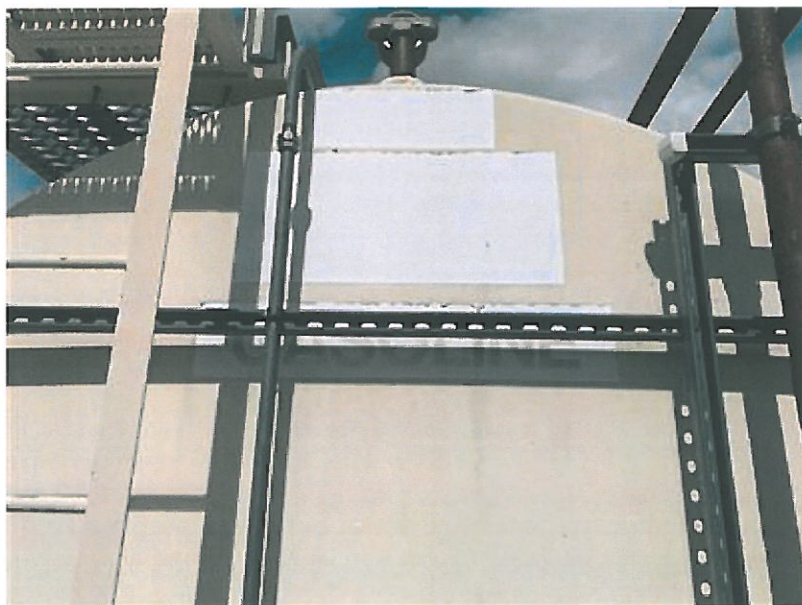
4e - Signage

**Tanks were observed with faded signage for product name and storage capacity.**

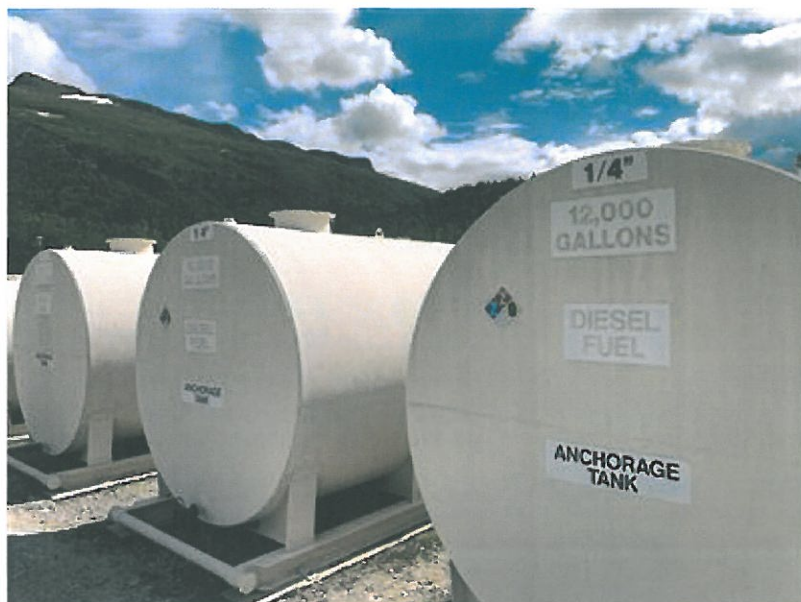
4f - Paint

**No signs of paint chipping or peeling on tanks.**
